Manhole Inspection Summary

Manhole # S23K__038MH

Location Address: **1500 W Pratt St**

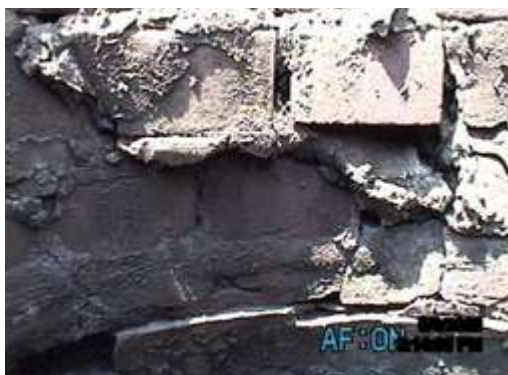
loose bricks missing rungs chimney

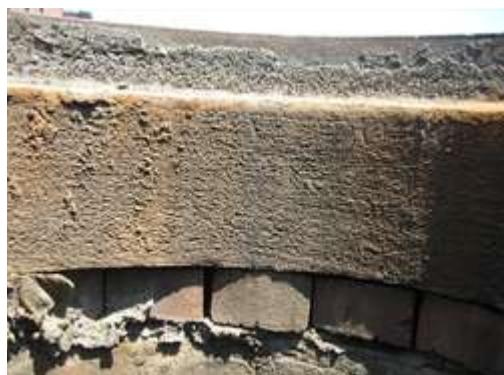
Defect 9

loose bricks, missing mortar, as well as lid-frame infiltration

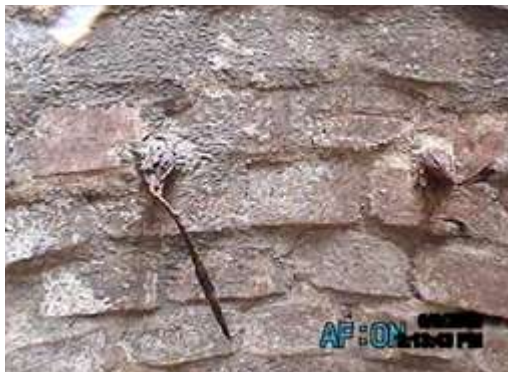
Defect 6

missing rung

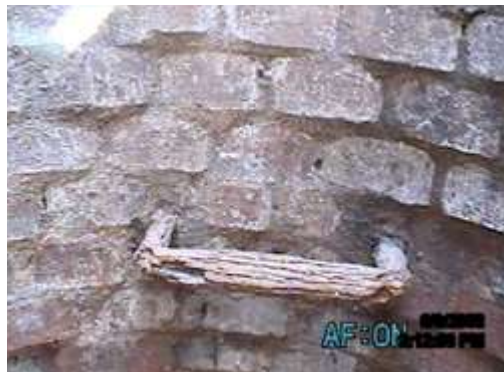
Defect 5

corroded rungs

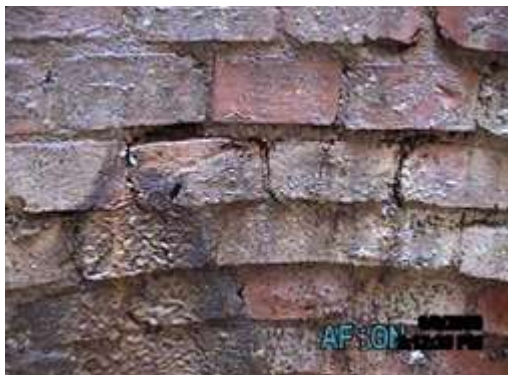
Defect 4

barrel infiltration

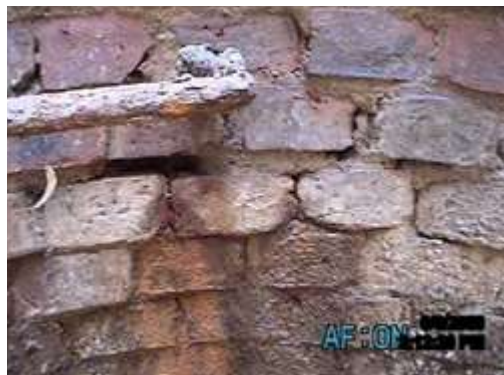
Defect 3

missing mortar, corroded rungs, corbel and barrel infiltration

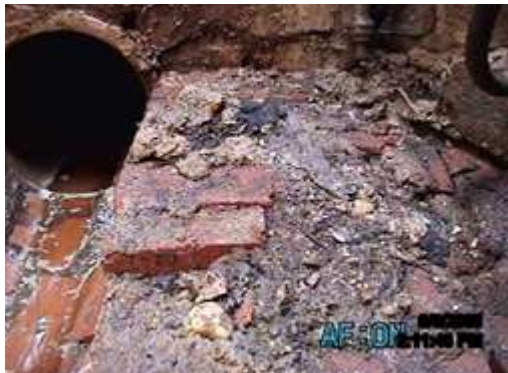
Defect 1

debris on bench

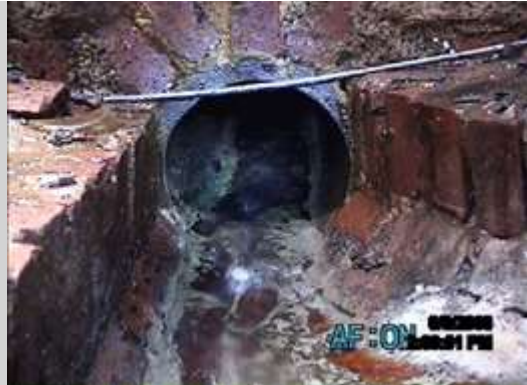
12 O'Clock Outflow

Pipe Height: **8.4** (in.) Rod and Bar (Angled)
Pipe Material: **Clay** ☐ Pipe Lined
Invert Depth: **11.20** (ft.) Flow Characteristics: **Fast**
Deposits: ☒ None ☐ Mud ☐ Sludge ☐ **Debris** ☐ Grease
Silt Depth: **0** (in.) Deposits Extent:
Infiltration: **None** Pipe Seal Cond: **Sound**

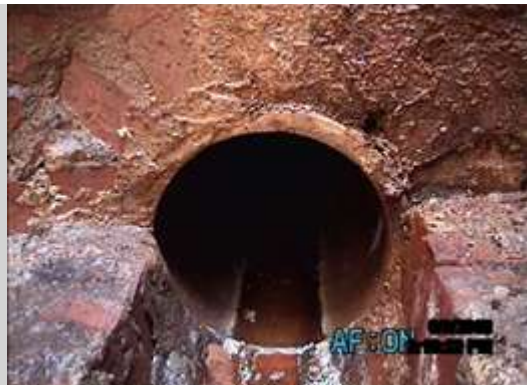
2 O'Clock Inflow

Pipe Height: **8.4** (in.) Rod and Bar (Angled)
Pipe Material: **Clay** ☐ Pipe Lined
Invert Depth: **10.48** (ft.) Flow Characteristics: **Slow**
Deposits: ☒ None ☐ Mud ☐ Sludge ☐ **Debris** ☐ Grease
Silt Depth: **0** (in.) Deposits Extent:
Infiltration: **None** Pipe Seal Cond: **Sound**

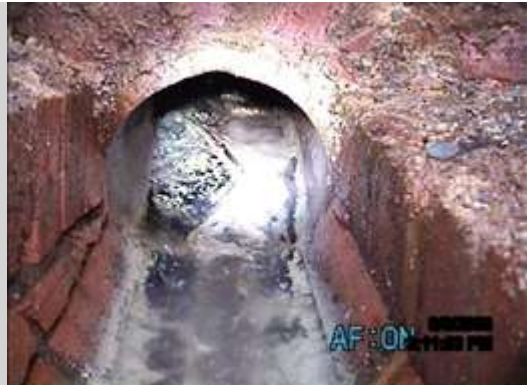
6 O'Clock Inflow

Deposits: ☐ None ☐ Mud ☐ Sludge ☒ **Debris** ☐ Grease

Silt Depth: **0.1** (in.) Deposits Extent: **Light**
